# PAINT CONDITION DECK

This sample deck contains representations of various paint conditions that may occur. The deck opens so that the sample card can be held next to the actual paint condition, to assist in the identification. The reverse side of each card contains information applicable to each condition.

## **DEALER TECHNICAL OPERATIONS PAINT CONDITION DECK**

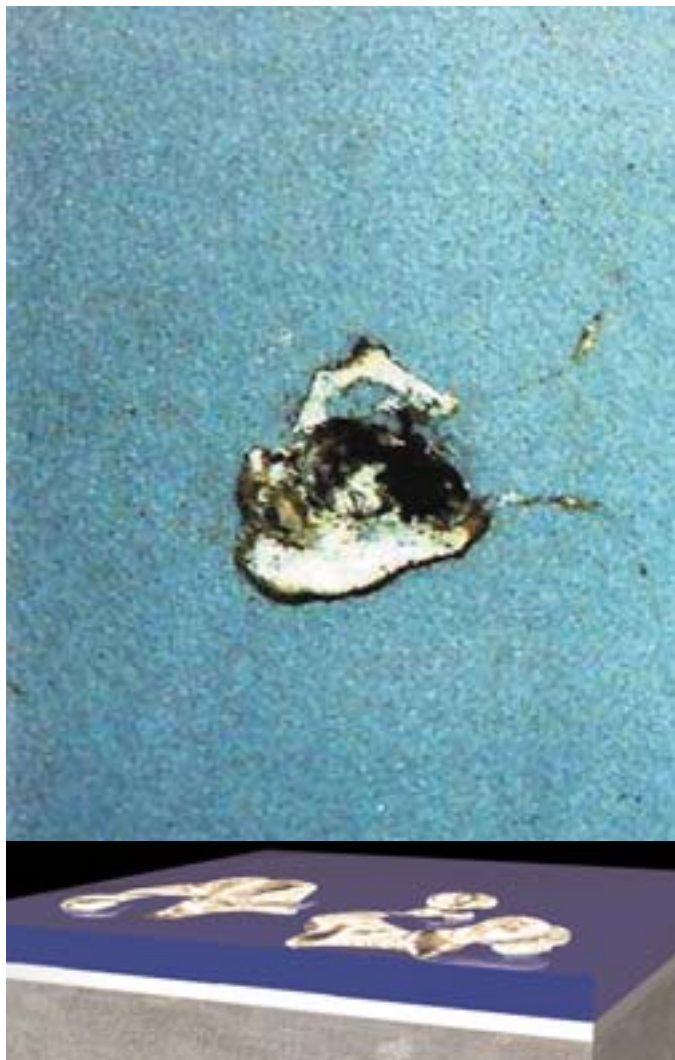
## **BIRD / BAT DROPPINGS**

Finish damage or spot etching. The longer the dropping stays on the finish, the more severe the etching may become.

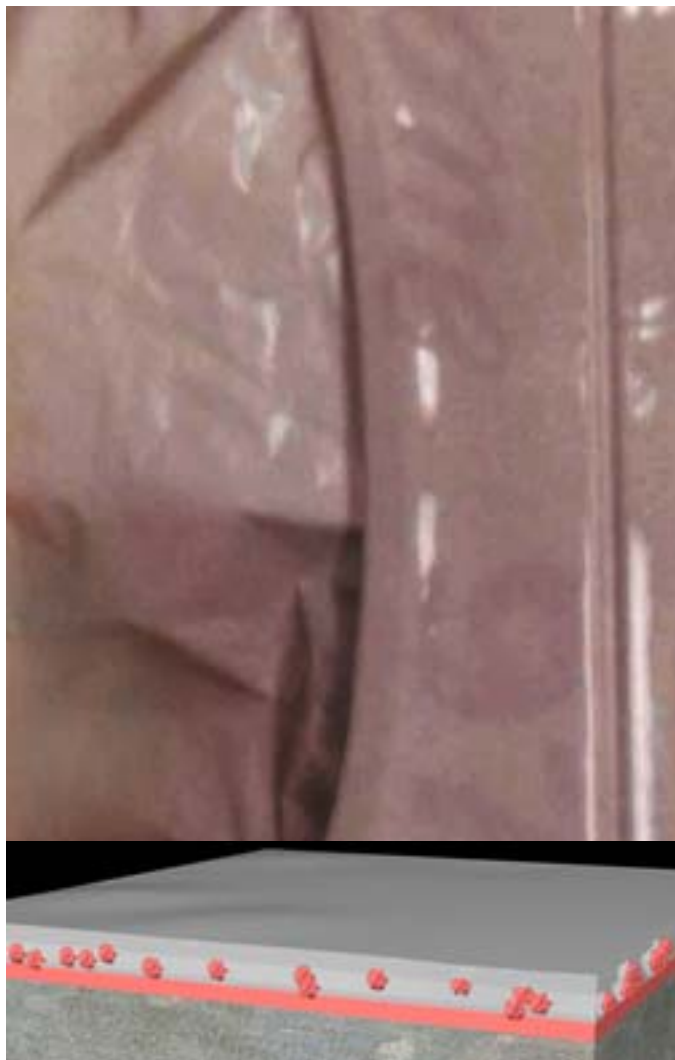
## **BLEEDING**

The staining from the substrate or undercoat to the topcoat color.

- The original coatings are dissolved by solvents in the repair material causing surface bleed-through.
- Peroxide in the polyester filler is dissolved by solvents in the repair material.

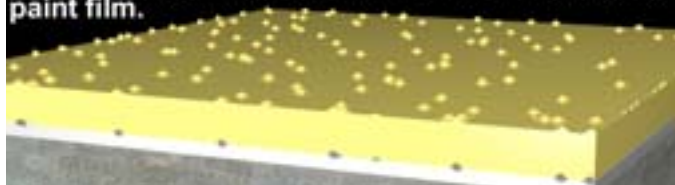
## BLISTERING

Moisture accumulates and expands, pushing up paint film.

- Moisture or contaminants trapped under the surface.

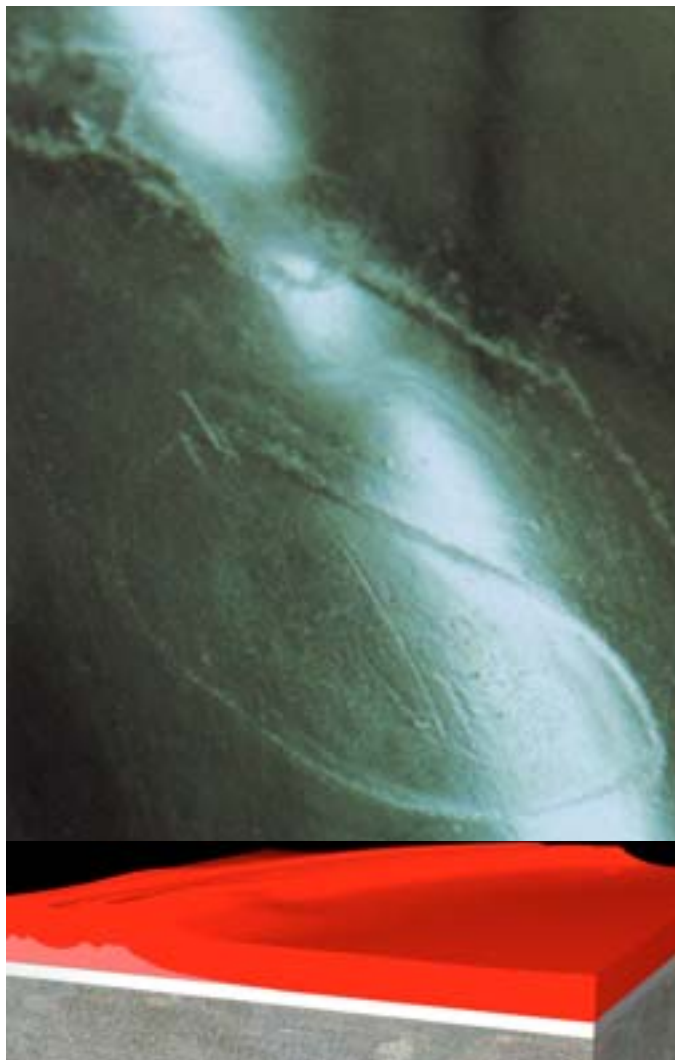
## **BULLSEYE**

Visible featheredge or sandscratches around repaired area.

- Improper surface preparation.
- Improper material application.

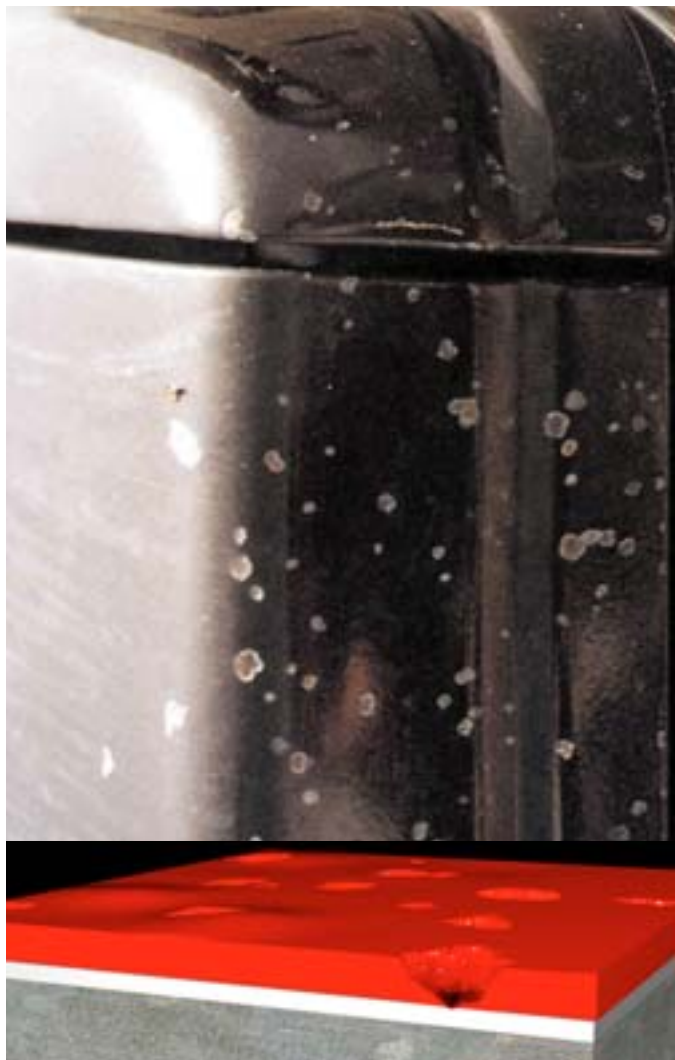
## CHIPPING

Small areas of paint film broken off the surface.

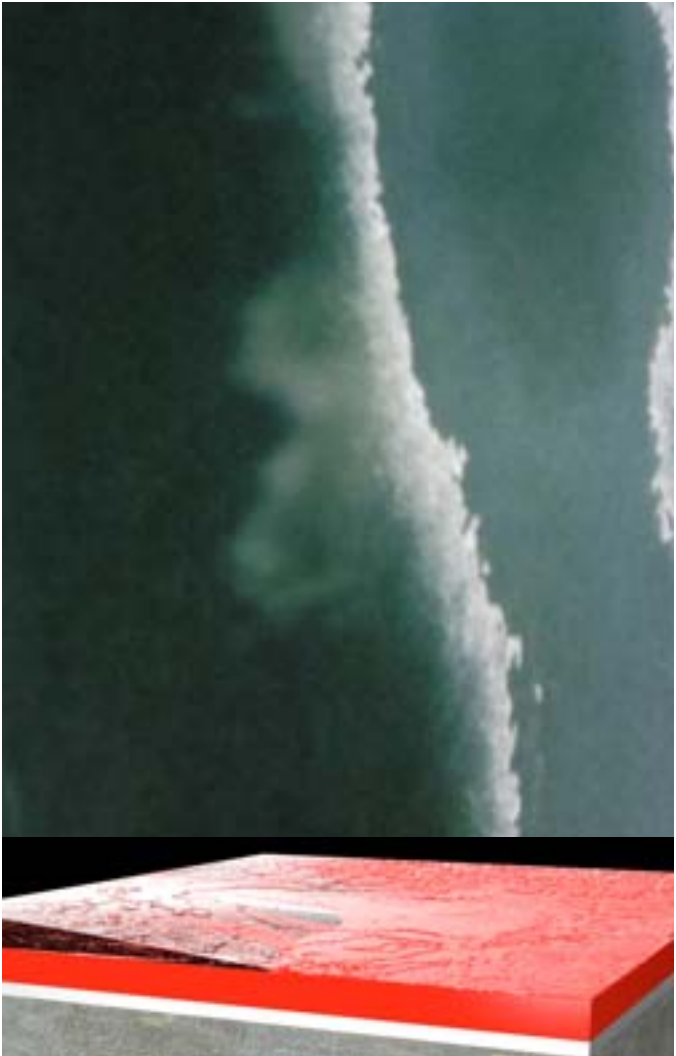
## CLEARCOAT EROSION

- Ultraviolet rays degrading the finish.
- More than .5 mil of clearcoat removed during a surface repair.

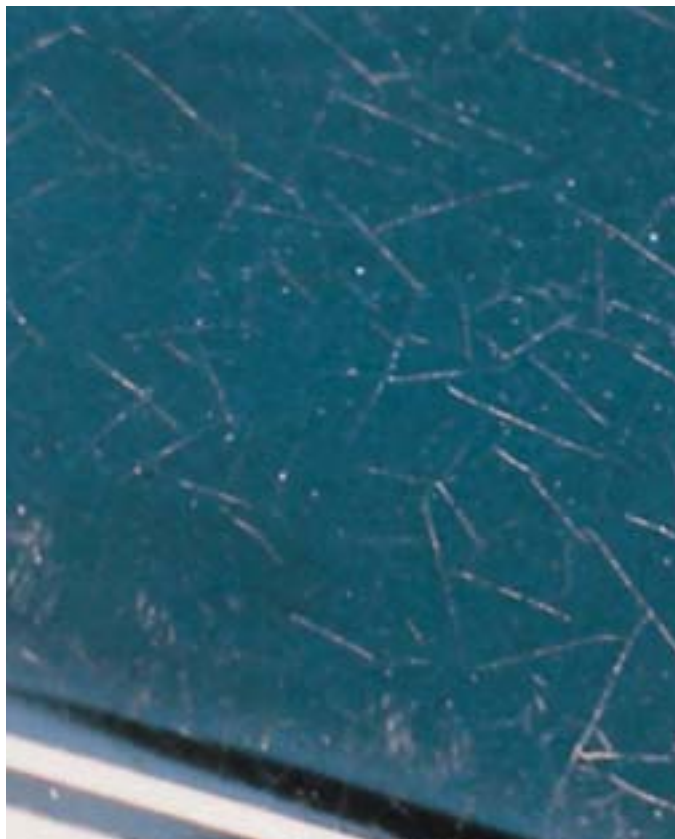
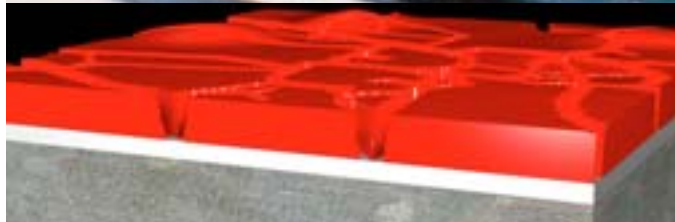
## CRACKING

A wide-spread, random pattern of fine hair line cracks in the paint surface.

- Excessive film thickness.
- Painting over a previously crazed or cracked surface.
- Improper mixing or application of materials.

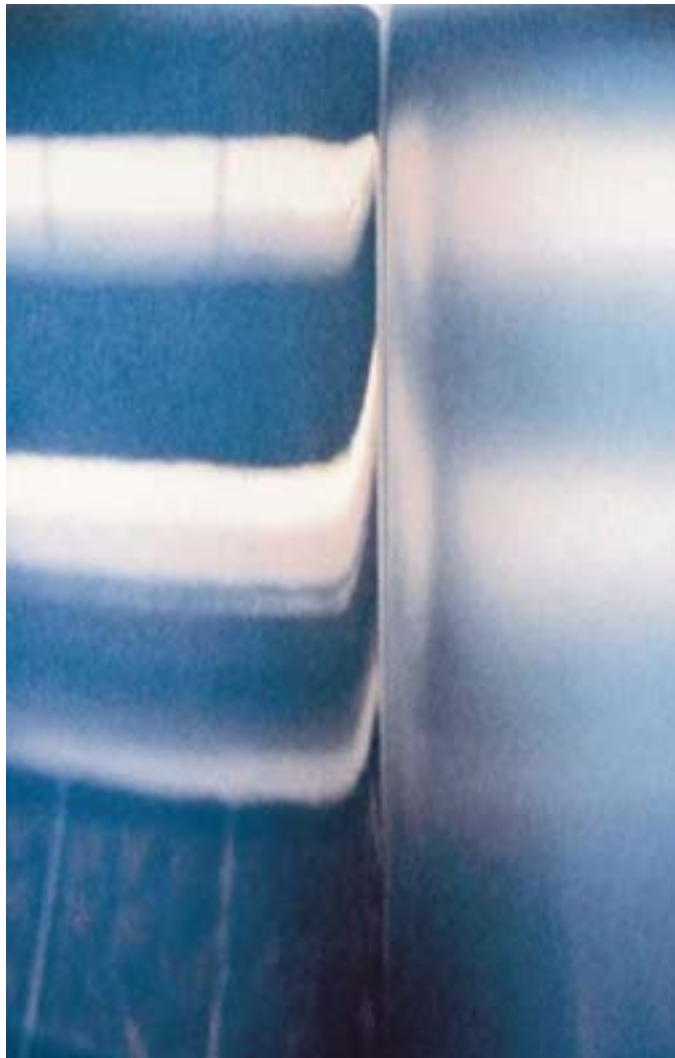
## **DIEBACK**

- Improper application of refinish coatings.
- Application over poor quality substrate.
- Solvent fumes or exhaust gases attacking the surface.
- Slow drying due to high humidity or low temperature.

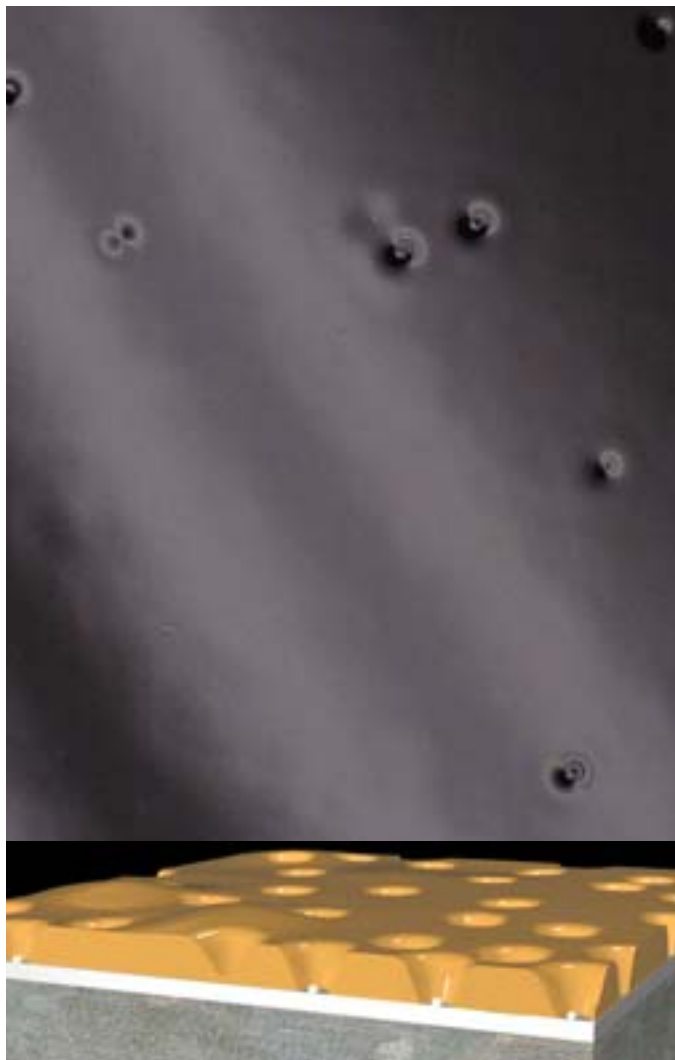
## FISHEYES

- Spraying over surfaces contaminated with oil, wax, silicone, grease, etc.
- Spraying over previously repaired areas containing “fisheye eliminator” additive.
- Air supply was contaminated with oil or water.
- External contaminants entering the spray area.

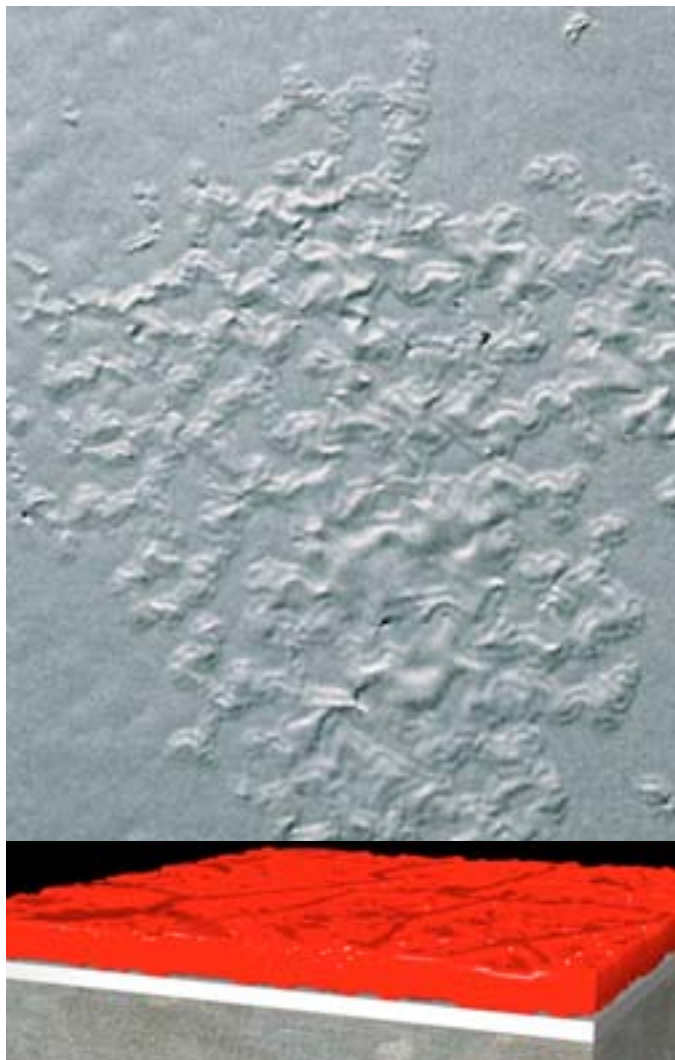
## LIFTING

- Recoating over incompatible materials.
- Recoating improperly cured finishes.
- Spraying over improperly cleaned surfaces.
- Exceeding maximum flash or recoating times.
- Heavy application coats.

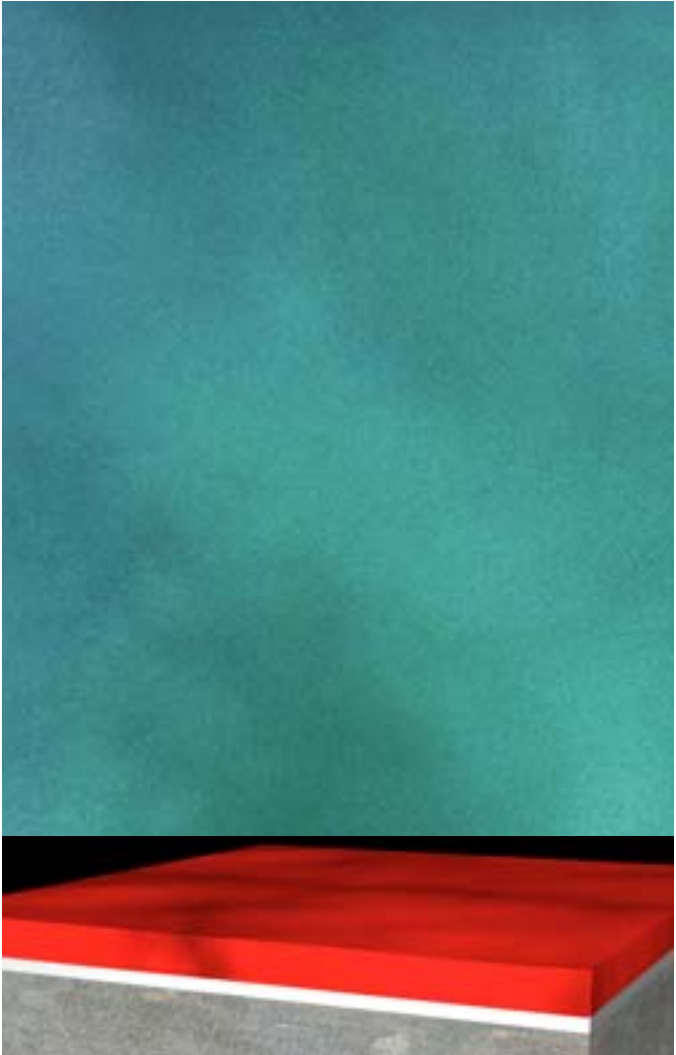
## **MOTTLING**

- Improper equipment or set-up.
- Incorrect reducer.
- Materials not uniformly mixed.
- Improper application.
- Uneven spray pattern.
- Low shop temperature.

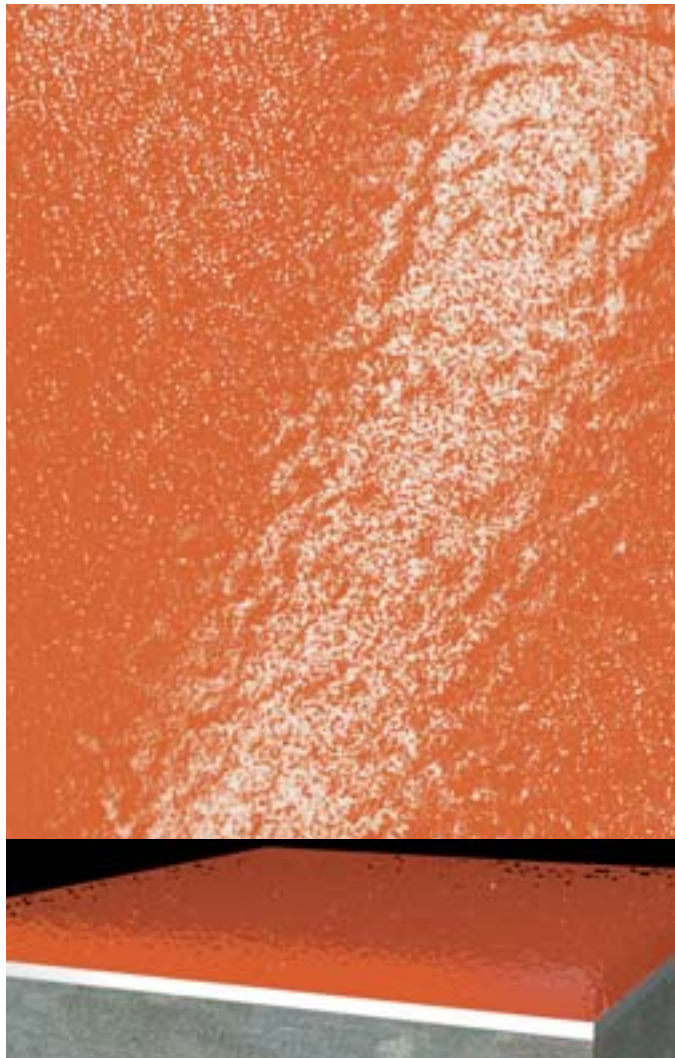
## **ORANGE PEEL**

- Under reduction and/or air pressure too low.
- Reducer evaporates too fast for spraying conditions.
- Excessive film thickness.
- Improper spray gun set-up and application.
- Viscosity of paint materials too high.

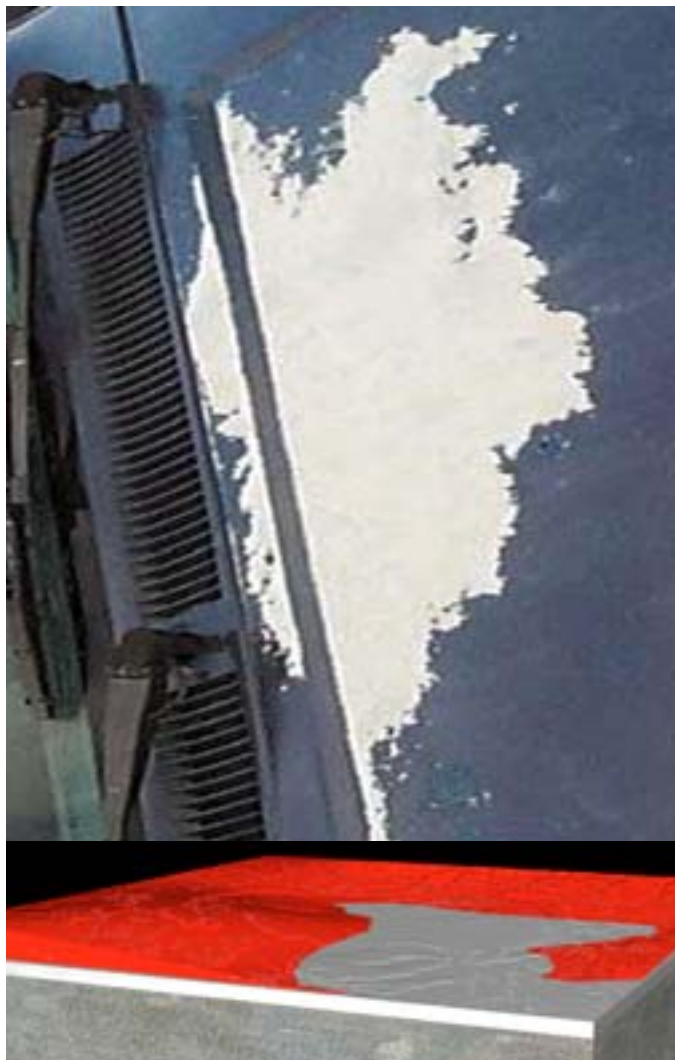
## **PAINT DELAMINATION**

- Ultraviolet ray penetration.
- Incompatible paint systems/materials used.
- Loss of adhesion between layers.
- More than .5 mil of clearcoat removed during surface repair.

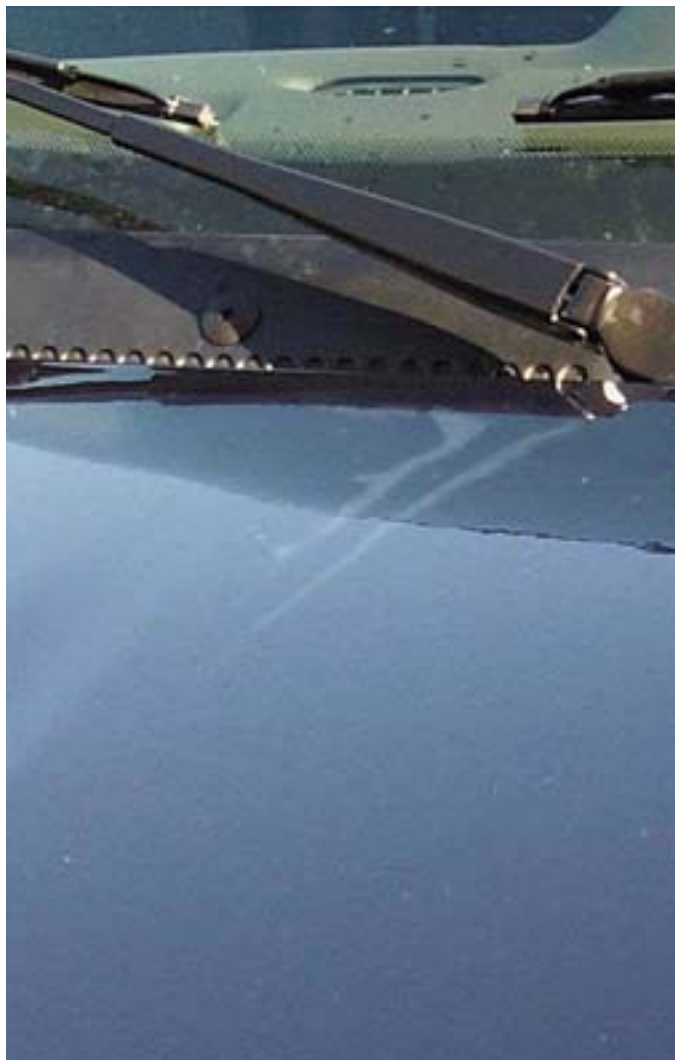
## PAINT WHITENING

Milky white or cloudy discolored area/spots. On light metallic colors it may appear as a coffee stain.

- Moisture trapped within the paint film.
- Aftermarket items, such as front-end covers or magnetic signs may produce this condition.

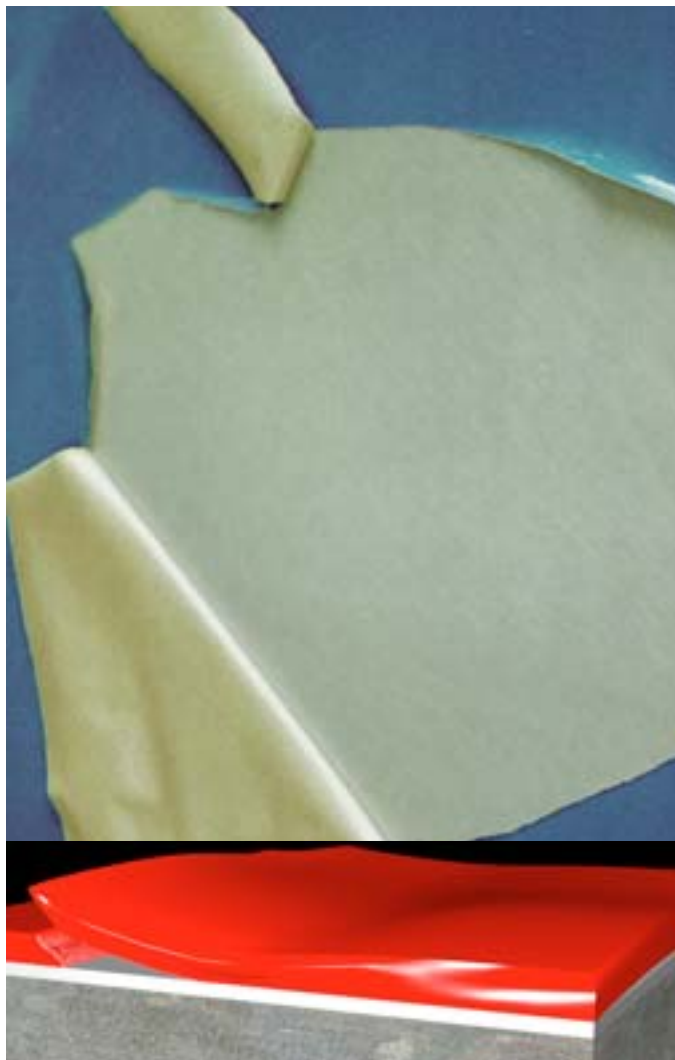
## PEELING

- Improper substrate cleaning or preparation.
- Omission of a product or procedure.
- Improper mixing or application of materials.
- Incompatible paint materials.
