Dealer Service Instructions for:

Safety Recall S14 / NHTSA 16V-077 Driver Airbag Module

2007-2009 (VB) Dodge Sprinter

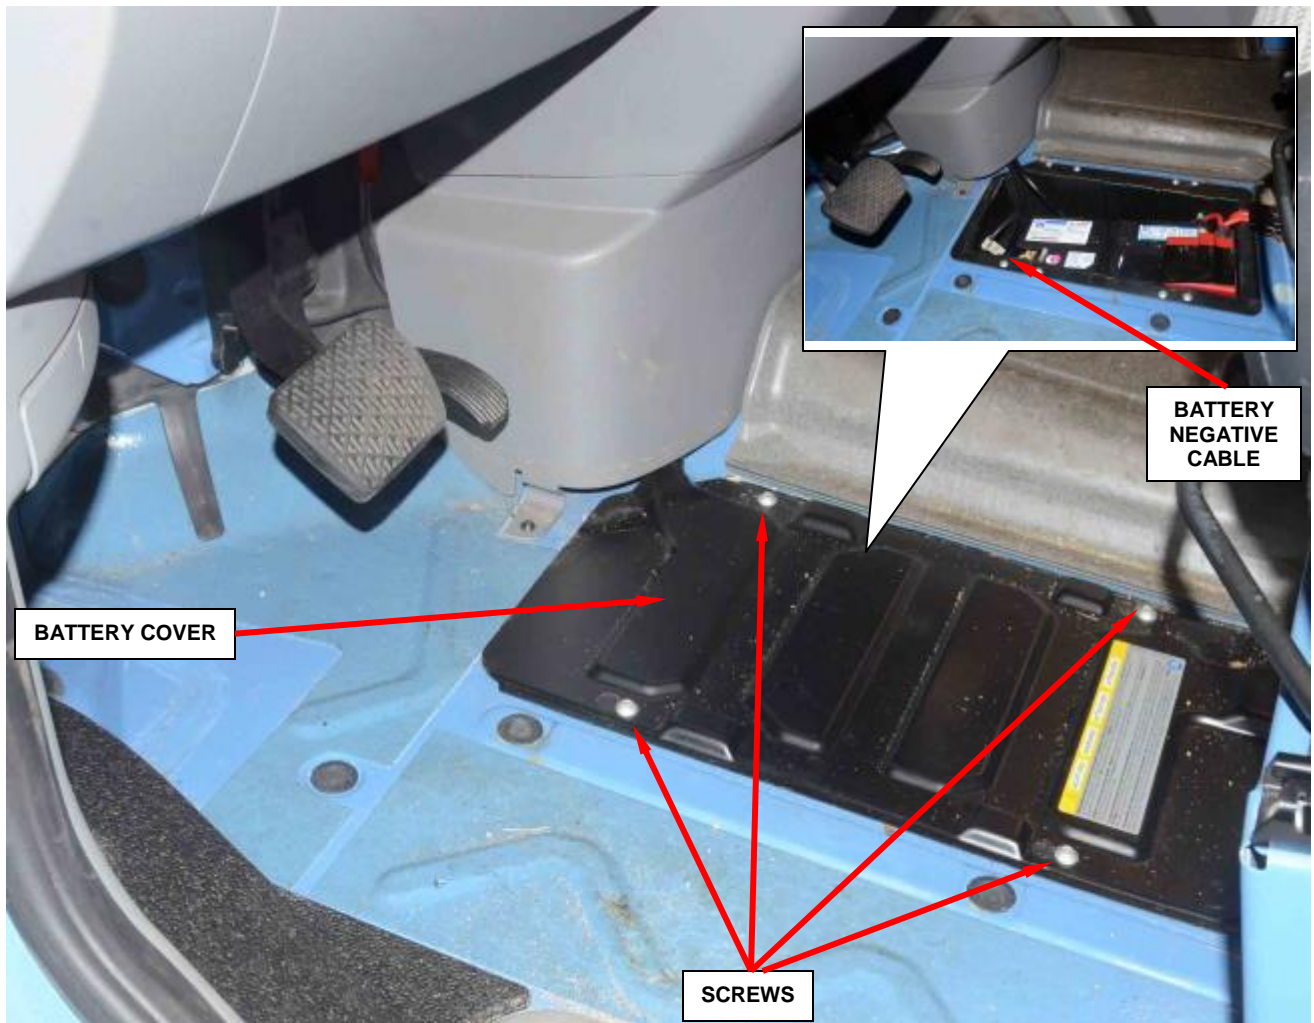
Figure 2 – Battery Location

- c. Remove and save the four screws from the battery cover and remove the battery cover (Figure 2).

- d. Disconnect and isolate the battery negative cable(s). Wait two minutes for the system capacitor to discharge before further service (Figure 2).

22. Install the battery cover and the four screws then tighten securely.
23. Install the rubber mat.
24. Install the door sill scuff plate and the three screws then tighten securely.
25. Return the original inflator as described in the Parts Return section.
26. Return the vehicle to the customer.

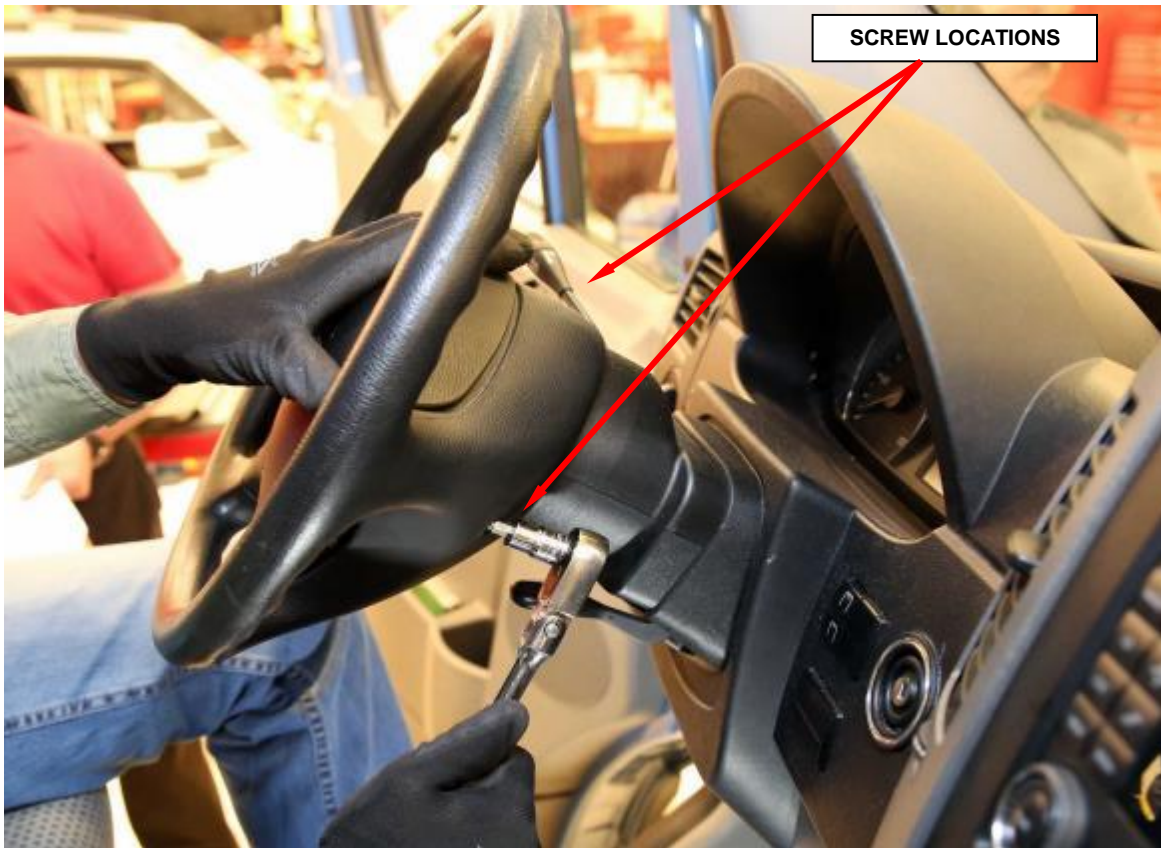
Figure 3 - Driver Airbag Screws

2. From the underside of the steering wheel, remove the two screws that secure the driver airbag to the steering wheel armature (Figure 3).

3. Pull the driver airbag away from the steering wheel far enough to access the electrical connections at the back of the airbag housing.

19. From the underside of the steering wheel, install and tighten the two screws that secure the driver airbag to the steering wheel armature. Tighten the screws to 53 in. lbs. (6 N·m).
20. **Do not connect the battery negative cable at this time.** The supplemental restraint system verification test procedure should be performed following service of any supplemental restraint system component.
